Remedial Action Plan Presentation

Site Chronology

Remediation Plan

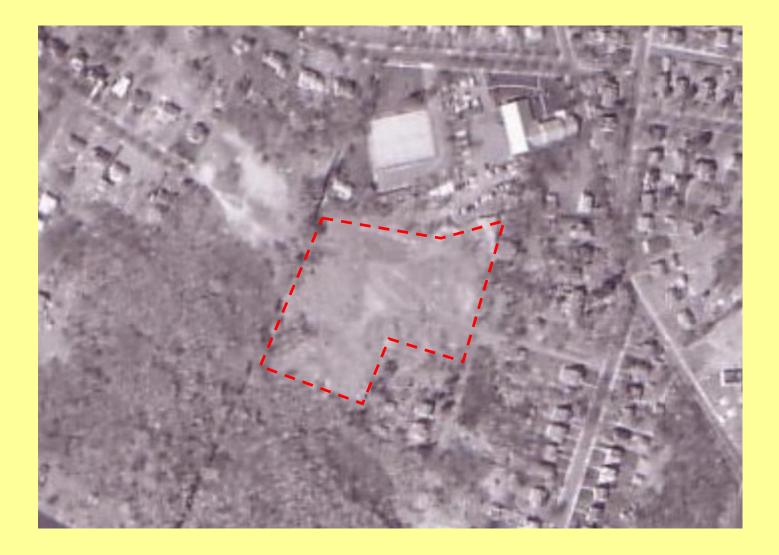
1959 Air Photograph Shortly Before Orchard School Construction

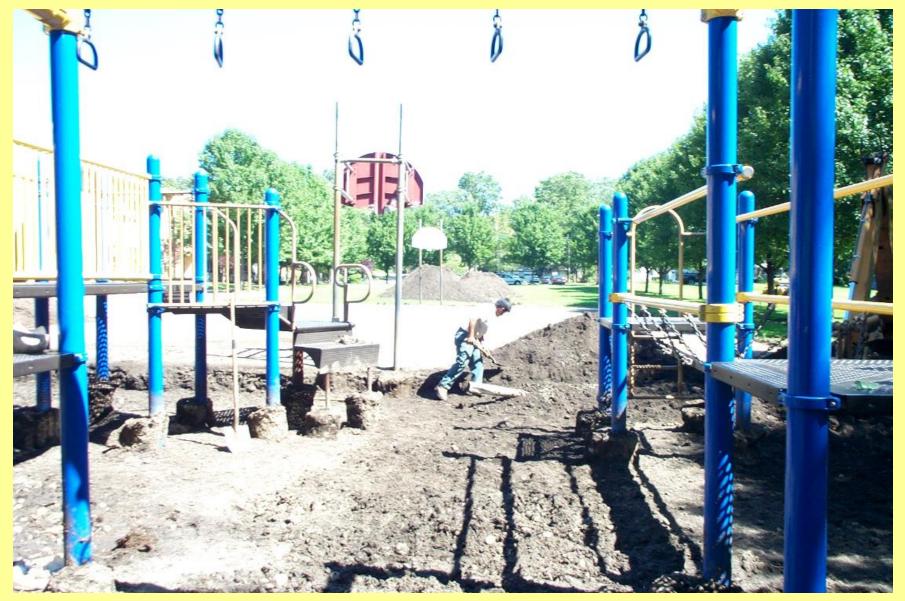
2000 – Areas Requiring Fill and Grading to Achieve Minimum 18-inch Depth to Ash

The cap at the site is primarily existing onsite soil (assumed to be clean). Some areas were regraded to ensure that the ash material was at least 18 inches below grade. Six inches of imported clean soil was added to the areas indicated to achieve required burial depth.

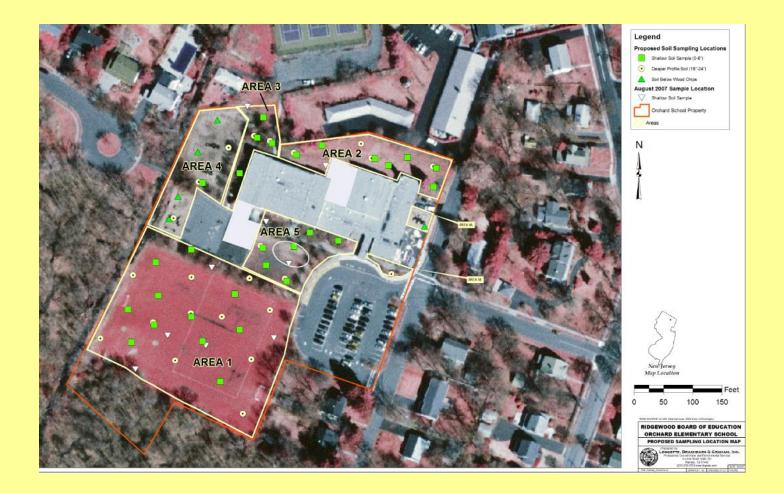
2007 Soil Sampling Program

PAHs detected above cleanup criteria

Additional sampling found that historic fill material extends across entire property and contain PAHs above criteria
